2. Damage caused by the earthquake and tsunami hitting Fukushima NPSs

(1) Seismic ground motion and tsunami height observed at Fukushima Dai-ichi NPS

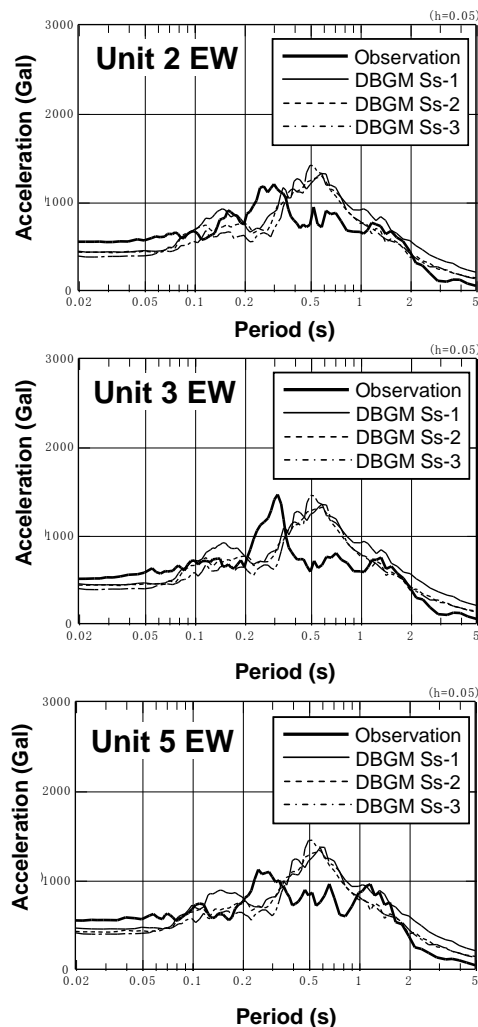
Fig. III-2-2(b) Response spectra on the base mats at R/Bs at Fukushima Dai-ichi NPS.

Figure III-2-2(b) shows the comparison chart between the response spectra of observed seismic ground motion at the base mat level of the reactor building of Units 2, 3 and 5 and the response spectra at the base mat level of the building, inputting the standard seismic ground motion Ss into the base mat. The Figure shows that the response spectra of observation records of Units 2, 3 and 5 exceeds the response to Ss with a period of 0.2 to 0.3 second.

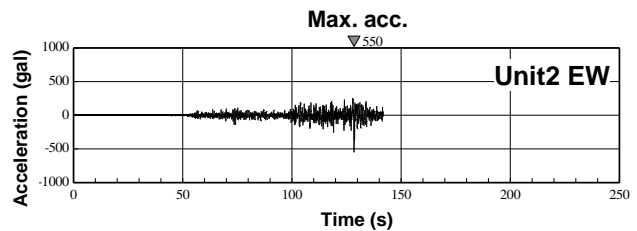
Fig. III-2-2(a) Acceleration seismogram on the base mat at R/B in Unit-2 at Fukushima Dai-ichi NPS.

motion Ss at the site where seismometers were installed at the base mat level on the first basement level of the reactor buildings. The table shows that observed maximum acceleration is mostly smaller than maximum response acceleration to the standard seismic ground motion Ss. However, maximum acceleration observed in east-west direction at Units 2, 3 and 5 is larger than maximum response acceleration to Ss. Figure III-2-2(a) shows acceleration time history of east-west component in Unit 2.

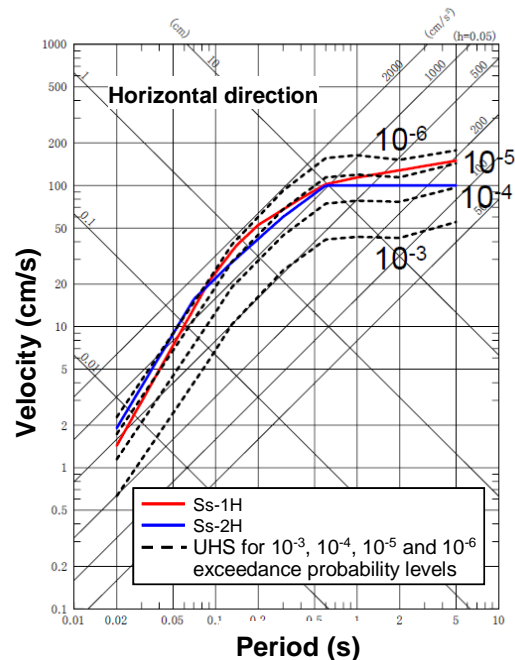
Fig. III-2-3 DBGM Ss and Uniform Hazard Spectra (UHS) for Fukushima Dai-ichi NPS.

Figure III-2-3 shows the uniform hazard spectra of Fukushima Dai-ichi NPS. In the Figure, Ss-1H and Ss-2H response spectra are also shown. The figure shows exceedance probability of the standard seismic ground motion Ss is within the range of 10^{-4} to 10^{-6} per year.

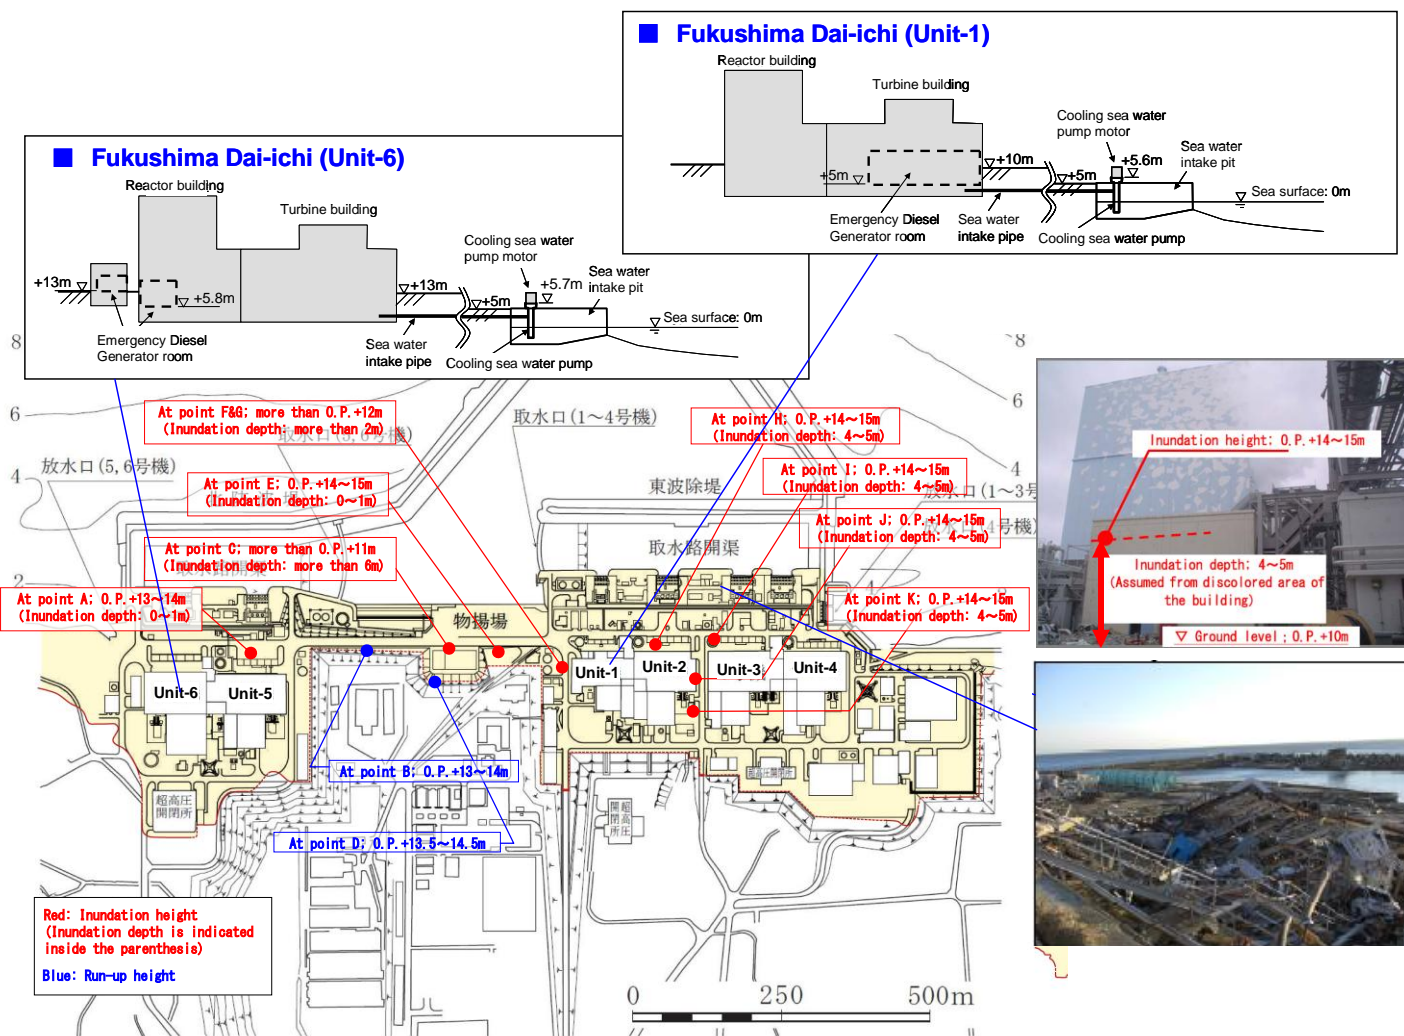
Fig. III-2-4(a) Damage of Fukushima Dai-ichi NPS due to the tsunami.

The site height of Fukushima Dai-ichi NPS is 10 m at Units 1 to 4, and 13 m at Units 5 and 6. At Fukushima Dai-ichi NPS, tsunami rushed from the offshore area in front of the site, and most part of the site where main buildings were placed was flooded. TEPCO reported about the inundation height based on the results of trace investigation at flooding. The results of the report are shown in Figure III-2-4. The inundation height of the ocean-side site such as reactor buildings of Units 1 to 4, turbine buildings, etc. is O.P. approximately +14 to 15 m at points H to K in the Figure(O.P.: Onahama Port base tide level for construction). Experts estimate that the tsunami height caused by this earthquake is more than 10 m from the picture (refer to Fig. III-2-5) showing the overflow status of tsunami seawall (10 m) released by TEPCO. It is hence assumed that tsunami height at the sea water pump is more than 10 m.

As to the sea water pump facilities for component cooling (height: 5.6 to 6 m) at Fukushima Dai-ichi NPS, all Units were flooded by tsunami as shown in Figure III-2-4. Whether or not they were damaged by wave power is under investigation. In addition, the Emergency Diesel Generators and switchboards installed in the basement floor of the reactor buildings and the turbine buildings (height: 0 to 5.8 m) were flooded except for Unit 6, and the emergency power source supply was lost. Regarding Unit 6, two out of three Emergency Diesel Generators were installed in the first basement of the reactor building and was flooded, but one Generator installed on the first floor of Diesel Generator building was not flooded and the emergency power supply was possible.

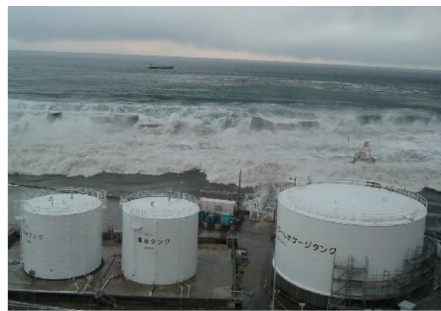
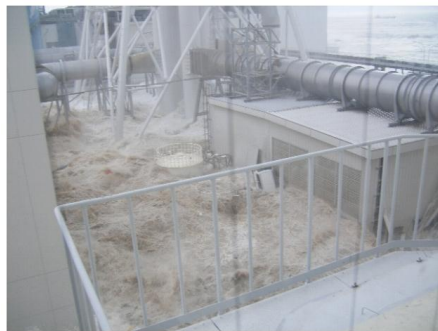
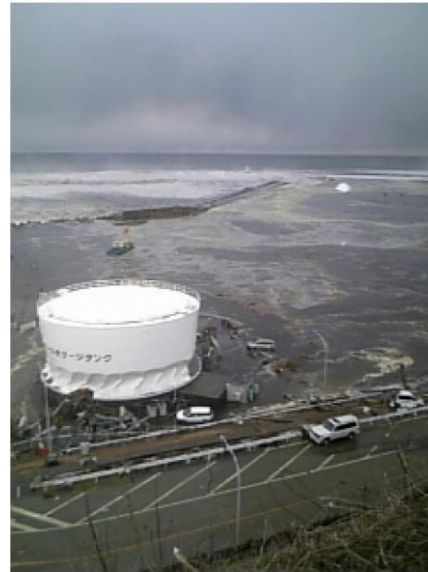
Fig. III-2-4(b) Photos showing plant damages at the Fukushima Dai-ichi NPS.

【福島第1原発 津波来襲状況 2011年3月11日 固体廃棄物貯蔵庫東側のり面(6号機の近傍(南側)から東側を撮影)＝東京電力提供】

【福島第1原発への津波来襲状況 2011年3月11日 廃棄物処理建屋4階から北側を撮影】午後3時43分ごろ(2)＝東京電力提供】

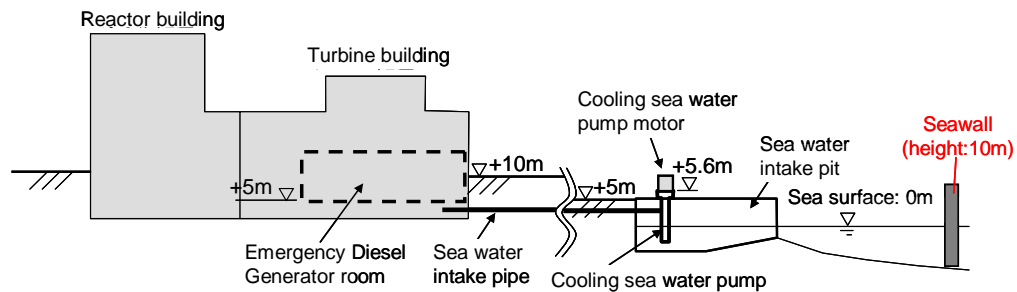
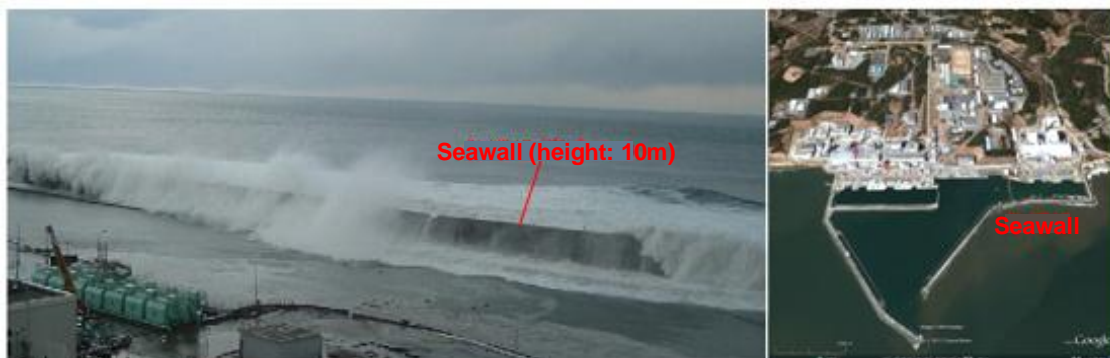
Fig. III-2-5 Tsunami getting over seawall at the Fukushima Dai-ichi NPS.

Cross section of Fukushima Dai-ichi (Unit-1)

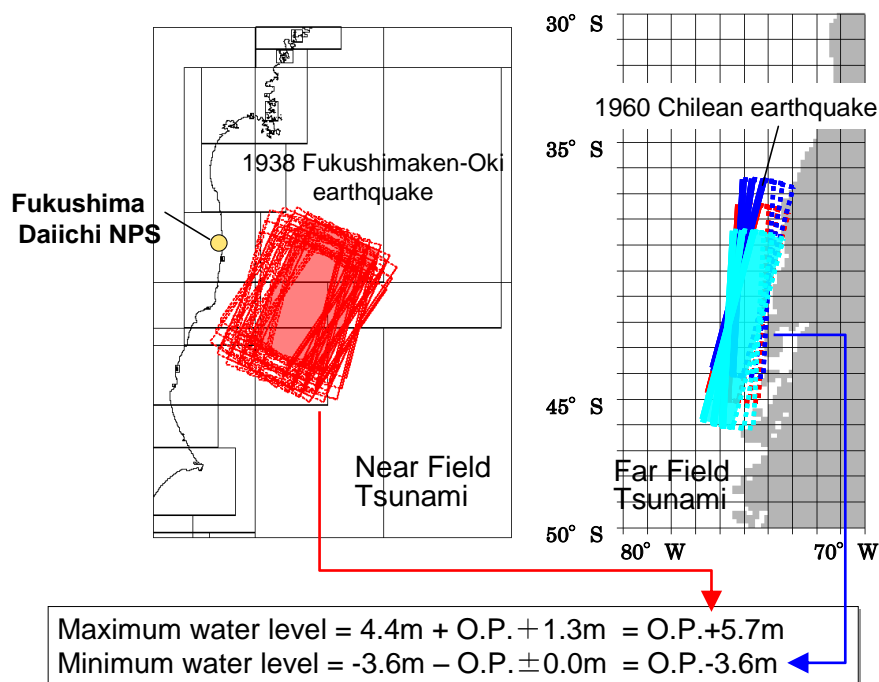
Fig. III-2-6 Design tsunami level evaluated by TEPCO for the Fukushima Dai-ichi NPS.

As shown in Figure III-2-6, in the application document for establishment permit, subject tsunami source is Chile Earthquake (M9.5 in 1960) and the design basis tsunami water level is 3.1 m. In 2002, TEPCO evaluated the design tsunami height based on the “Tsunami Assessment Method for Nuclear Power Plants in Japan (2002)” of the Tsunami Evaluation Subcommittee, the Nuclear Civil Engineering Committee, Japan Society of Civil Engineers (hereafter referred to as Tsunami Assessment Method of JSCE), assessing off the coast of Fukushima Prefecture Earthquake (M7.9 in 1938) shown in Figure III-2-6 as M8.0 voluntary, and the highest water level of each Unit was set as 5.4 to 5.7 m. According to the evaluation, elevation of Unit 6 sea water pump motor of

emergency diesel generator was raised up 20 cm and also that of sea water pump motor for High Pressure Core Spray was raised up 22 cm.

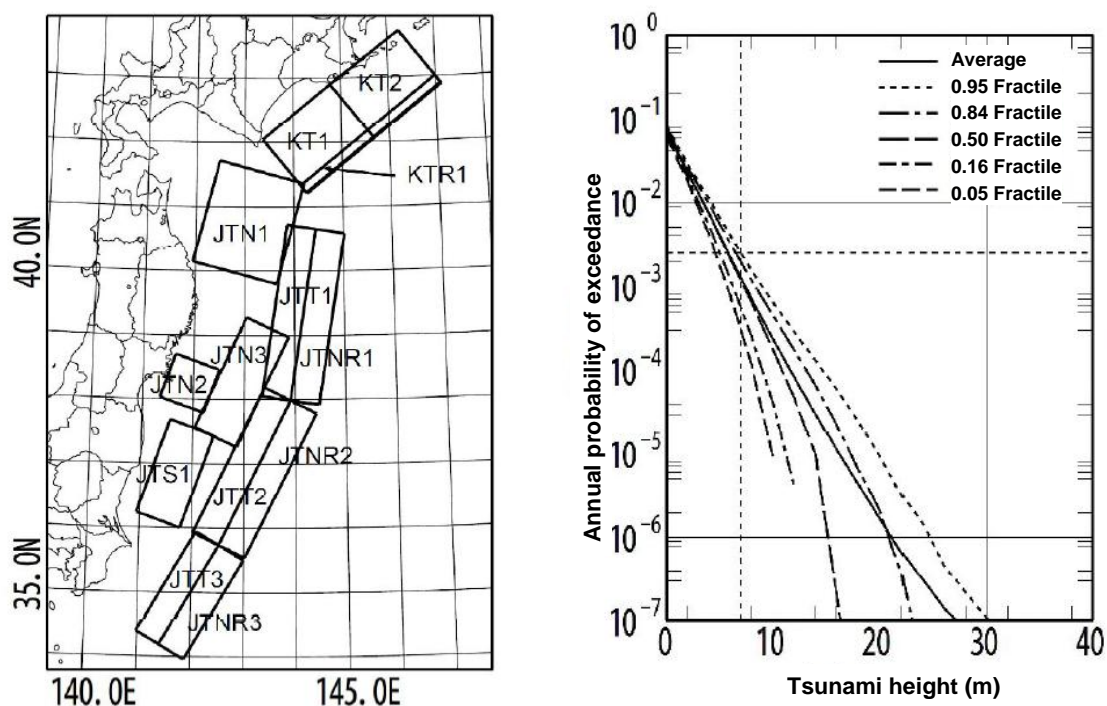
Fig. III-2-7 Evaluation results of tsunami hazard curves based on near- and far-field tsunami sources for Yamada villages, Iwate Pref..

The Tsunami Assessment Subcommittee of JSCE is at work on consideration about probabilistic tsunami hazard analysis method. As a part of the consideration, the tsunami hazard assessment method and the trial assessment of tsunami exceedance probability (Fig. III-2-7) are already announced but not yet completed. Other trial assessment of tsunami hazard is also announced.

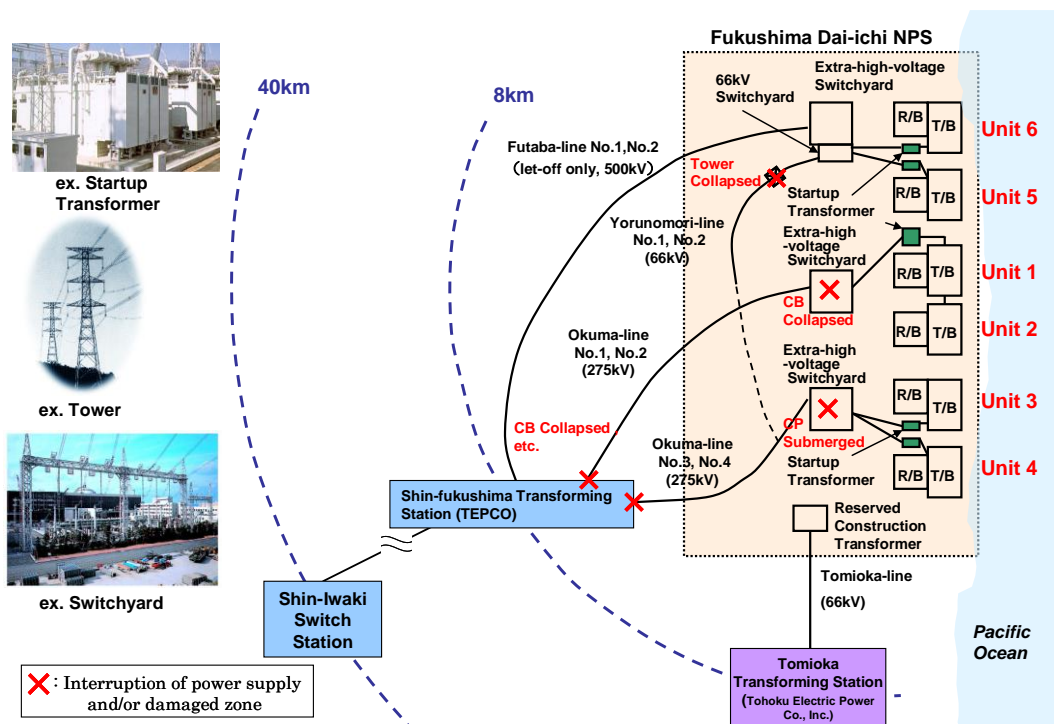
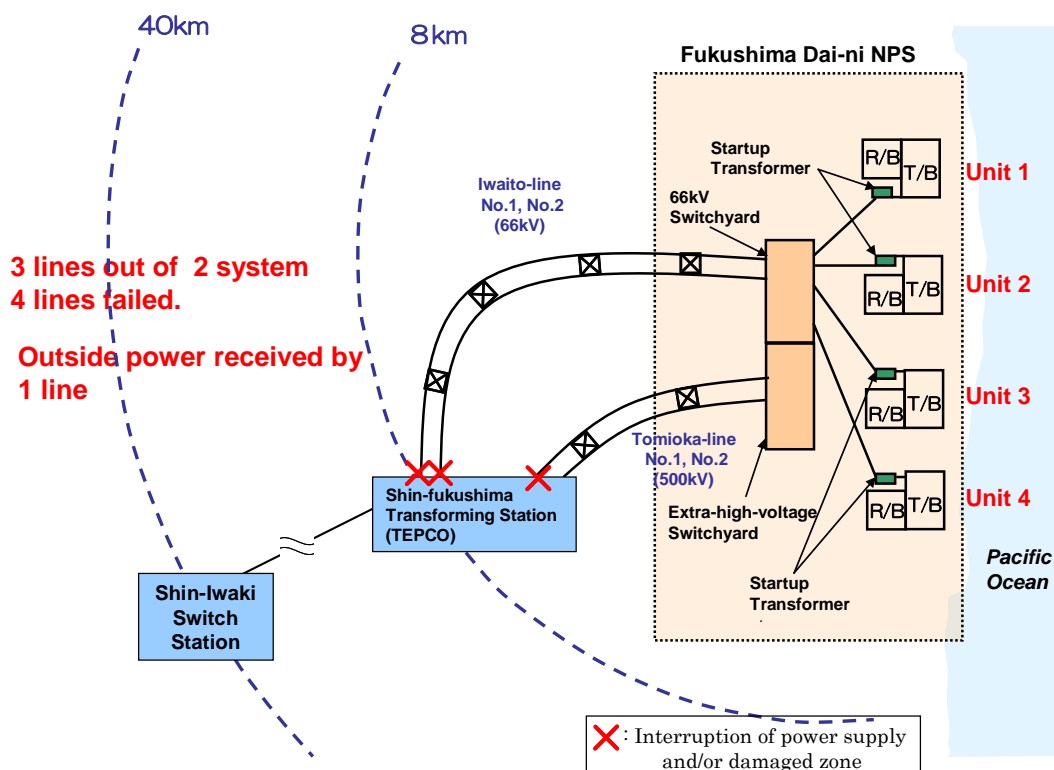
Fig. III-2-8(a) Damage of external power supply systems for the Fukushima Dai-ichi and Dai-ni NPSs (1).

Figures III-2-8(a) and III-2-8(b) show the transmission network of external power supply of Fukushima Dai-ichi NPS and the damage situation. As shown in the Figures, the Okuma Nos. 1 and 2 power transmission lines (275 kV) from Shin Fukushima Power Substation connected to the normal high voltage switchboards of Units 1 and 2 via the switchyards for Units 1 and 2, and in addition, TEPCO nuclear line (66 kV) from Tohoku Electric Power Co., Inc. connected to the normal high voltage switchboard of Unit 1 via the switchyards for Units 1 and 2. As to Units 3 and 4, the Okuma Nos. 3 and 4

The earthquake caused damage to the breakers of the switchyards of Units 1 and 2. As to TEPCO nuclear line from Tohoku Electric Power, although it is not possible to estimate the cause, cables were damaged. Concerning Units 3 and 4, in addition to the Okuma No. 3 transmission line under construction, the breakers of Nos. 3 and 4 transmission lines on the side of Shin Fukushima Power Substation failed. In addition, for Units 5 and 6, one transmission line tower (tower No. 27) connecting to the switchyards of Units 5 and 6 was collapsed. As a result, all external power supplies of Units 1 to 6 were lost.

The seismic intensity in the area around Shin Fukushima Power Substation is estimated to be 6 upper. The Tomioka No. 2 transmission line (500 kV) and the Iwaido No. 2 transmission line (66 kV) to Units 1 to 4 of Fukushima Dai-ni NPS stopped transmission due to failure of devices on the side of the switchboard, caused by strong ground motion in this earthquake. However, the power supply to Units 1 to 4 was continued since the Tomioka No. 1 transmission line could supply electric power (refer to Fig.III-2-8(a)).

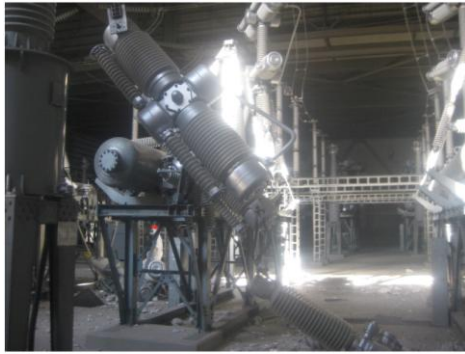
**Okuma line 1L (O-81)
Circuit Breaker damaged**

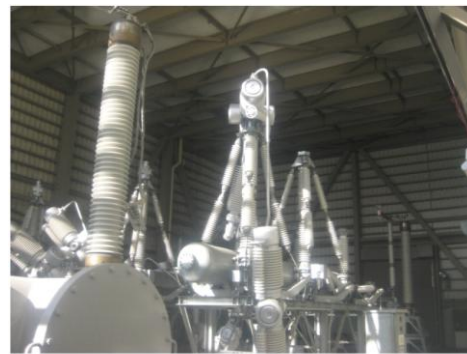
**Okuma line 2L (O-81)
Circuit Breaker damaged**

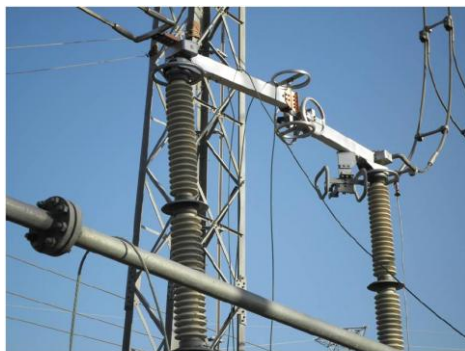
**Okuma line 3L, Ground wire
(disconnected)**

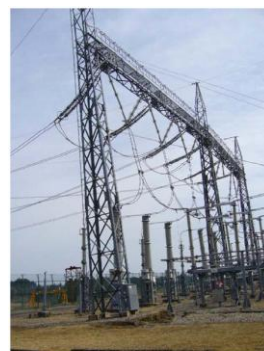
**Okuma line 3L & 4L, Steel
structure for lead-in (tilted)**

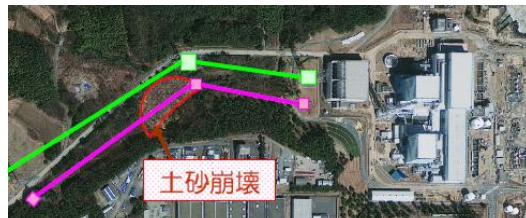
Landslide of slope

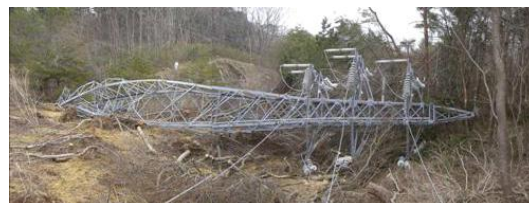
Collapsed tower

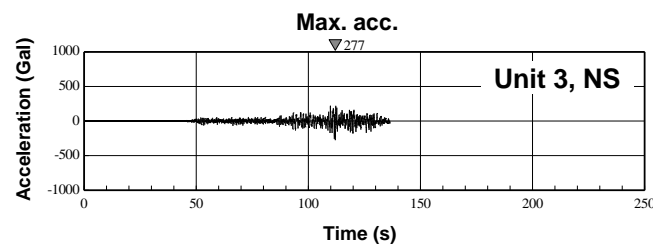
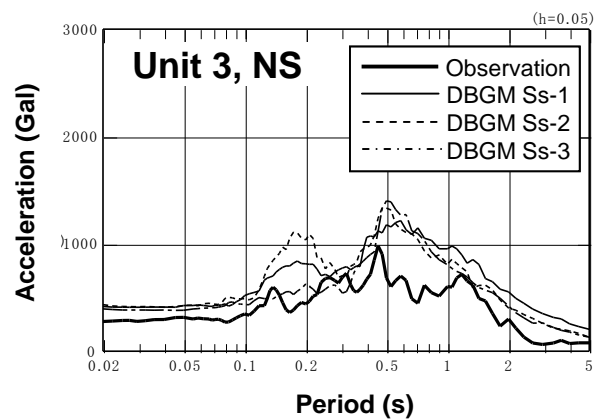
Fig. III-2-9 Acceleration seismogram and response spectra on the base mat at R/B in Unit-3 at the Fukushima Dai-ni NPS.

Figure III-2-9 shows the acceleration time history and the response spectra of observed seismic ground motion at the base mat level of the reactor building of Unit 3 whose acceleration in horizontal direction was highest. The figure also shows the response spectra on the base mat level inputting the standard seismic ground motion Ss into the base mat. The figure implies that the response spectra obtained from observation records

fall below the response spectra inputting the standard seismic ground motion Ss

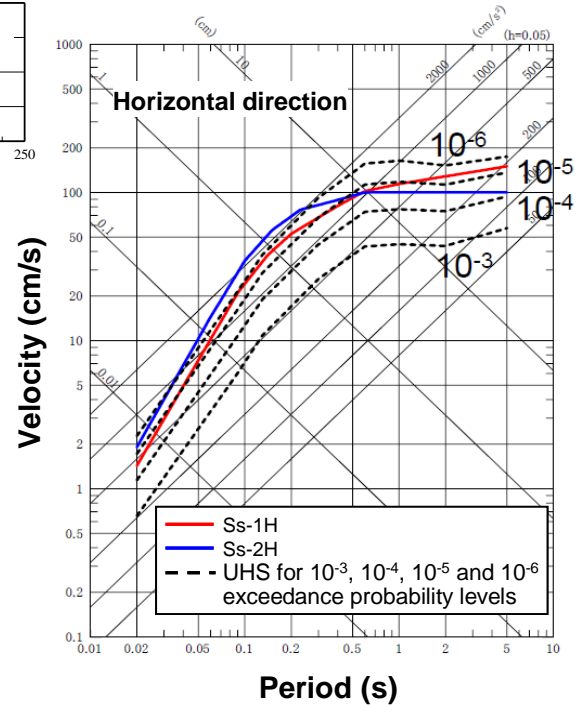
Fig. III-2-10 DBGM Ss and Uniform Hazard Spectra (UHS) for the Fukushima Dai-ni NPS.

Figure III-2-10 shows the uniform hazard spectra of Fukushima Dai-ni NPS. The response spectra of Ss-1H and Ss-2H are also shown. The Figure shows that the exceedance probability of the standard seismic ground motion Ss is within the range of 10^{-4} to 10^{-6} per year.

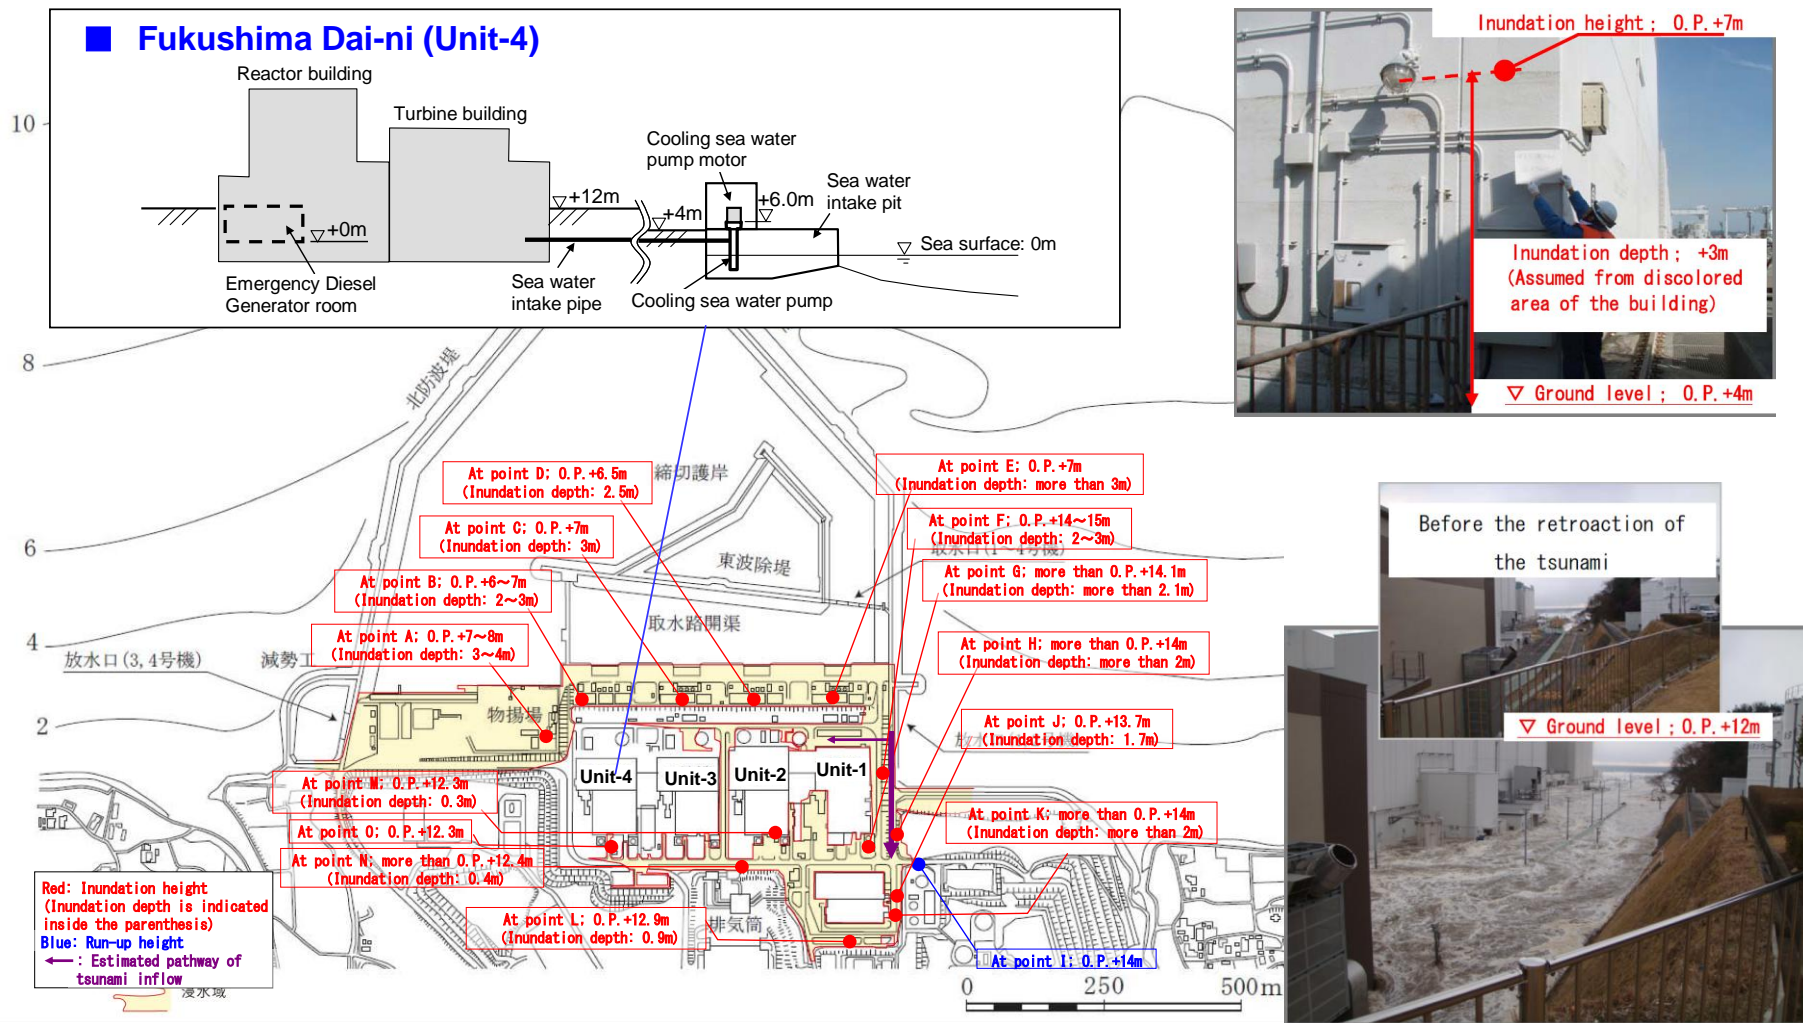
Fig. III-2-11(a) Damage of Fukushima Dai-ni NPS due to the tsunami.

TEPCO reported about the inundation height based on the results of trace investigation at flooding as well as Fukushima Dai-ichi NPS previously described in section 2.(1). Figure III-2-11(a) shows the report results. Fukushima Dai-ni NPS consists of the ocean-side area where seawater pumps, etc. are installed and the raised mountain-side area where reactor buildings, turbine buildings, etc. are installed. Tsunami at first flooded from the ocean-side area in front of the site. Afterward, as shown in the Figure, tsunami flooded from the narrow space between the south side of Unit 1 and the slope in the mountain-side area, and reached the back of the mountain-side area. There was no flooding except from the narrow place. The inundation height in the ocean-side area was O.P. approximately +6.5 to 7 m, and O.P. approximately +14 to 15 m in the mountain-side area (O.P. means base level of Onahama Port construction).

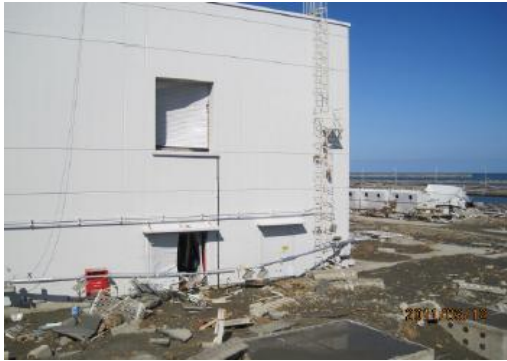
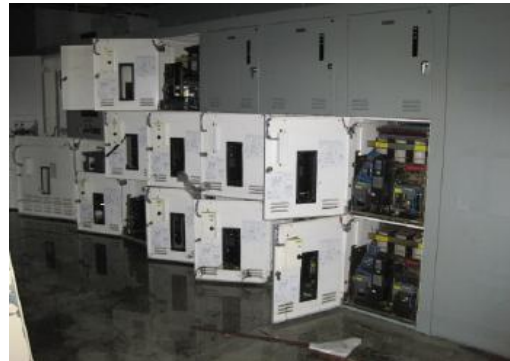
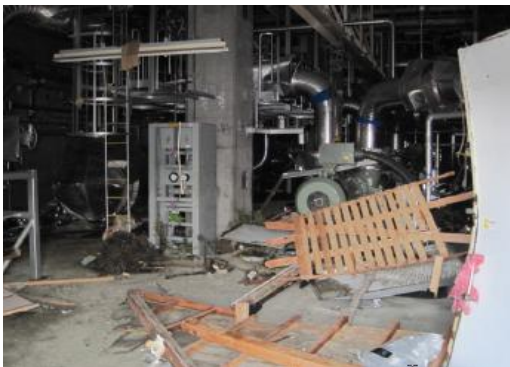
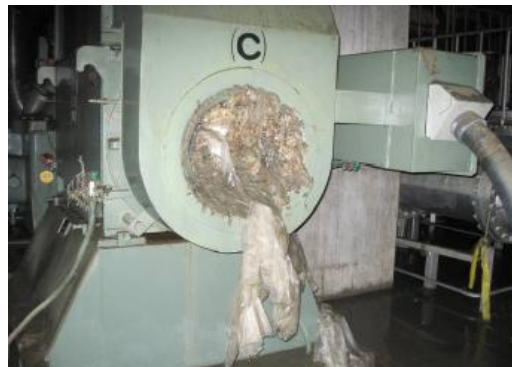
The sea water pump facilities for component cooling of all Units (height: 6 m) were flooded by tsunami and lost its function except Unit 3, which was not flooded and kept its function.

Damages of heat exchanger room and heat exchanger (Unit 1)

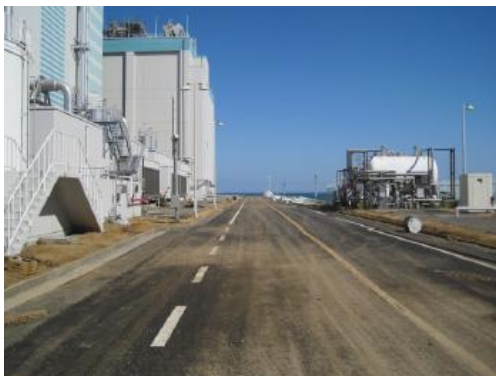
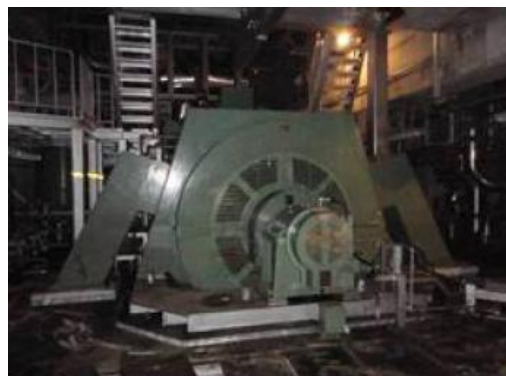
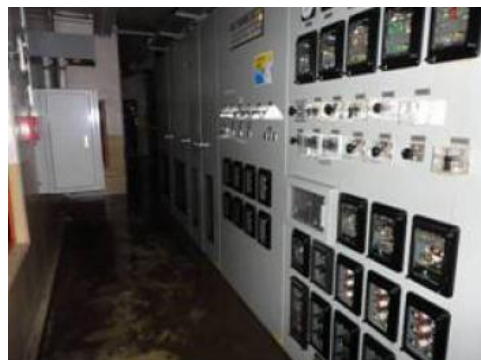
The Emergency Diesel Generators installed in the basement of the reactor buildings (height: 0 m) kept their functions for Unit 3 and 4, however, those for other Units lost

their functions by completely flooding (Fig. III-2-11(b)).

Damages of reactor building and emergency diesel generator (Unit 1)
