### 3. Seismic and tsunami damage to other NPSs

#### (1) Seismic ground motion and tsunami height observed at Onagawa NPS

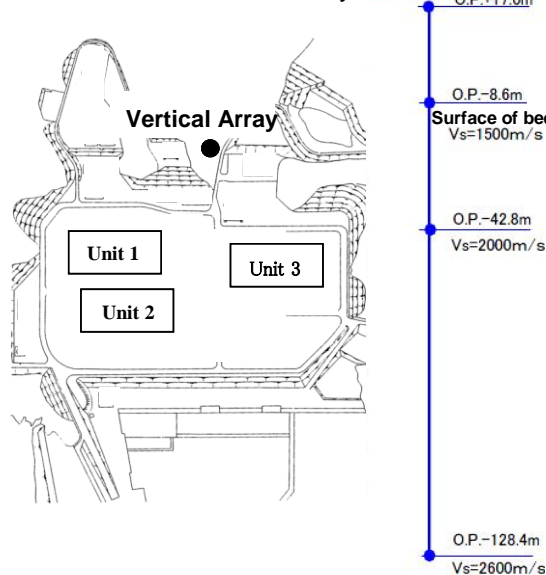
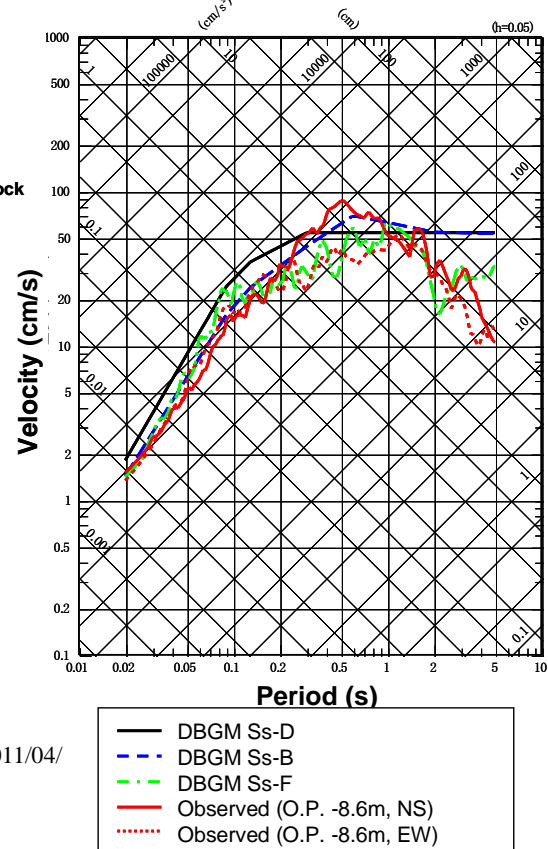
Fig. III-3-1 Deployment of seismometers and comparison of observed response spectra with the DBGM Ss on a free surface (equivalent to the base stratum) at Onagawa NPS.

Figure III-3-1 shows a comparison between response spectra of the observed seismic ground motions at the upper part of the bedrock on the site and response spectra for the standard seismic ground motion Ss. Response spectra of the observed seismic ground motions exceed response spectra for the standard seismic ground motion Ss in the periodic band between 0.2 and 1.0 sec.

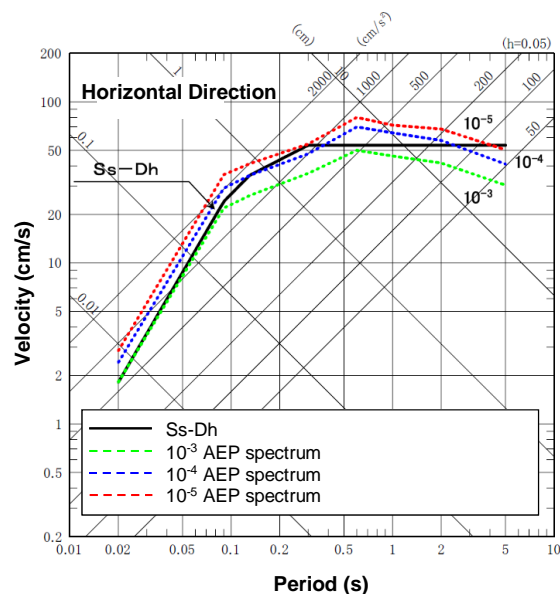
Fig. III-3-2 DBGM Ss and Uniform Hazard Spectra (UHS) for Onagawa NPS.

Figure III-3-2 shows the evaluation of the uniform hazard spectrum of DBGM Ss for Onagawa NPS. Response spectra for Ss-Dh are also shown in the figure. The exceedance probability for Ss is between  $10^{-3}$  and  $10^{-5}$  per year.

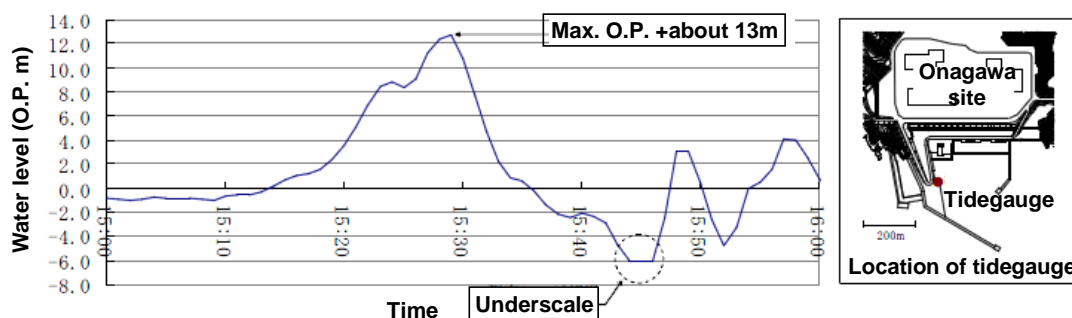
Fig. III-3-3 Time history of water level changes observed at Onagawa NPS.

Figure III-3-3 shows the tsunami time history recorded by the tide gauge. From the record, it can be seen that the first big wave arrived at about 15:29 (43 min after the main shock). The observed tsunami height was about 13 m relative to O.P. (O. P.: the reference surface for construction of Onagawa NPS), which did not exceed the height of the site, i.e. 13.8 m relative to O.P. (the real height of the site is 14.8 m, adjusted to sinking by about 1 m due to crustal deformation, according to the Geographical Survey Institute QE, see Figure III-3-4). Although seawater was found to have entered the sea-facing side of the site, it did not reach the major buildings.

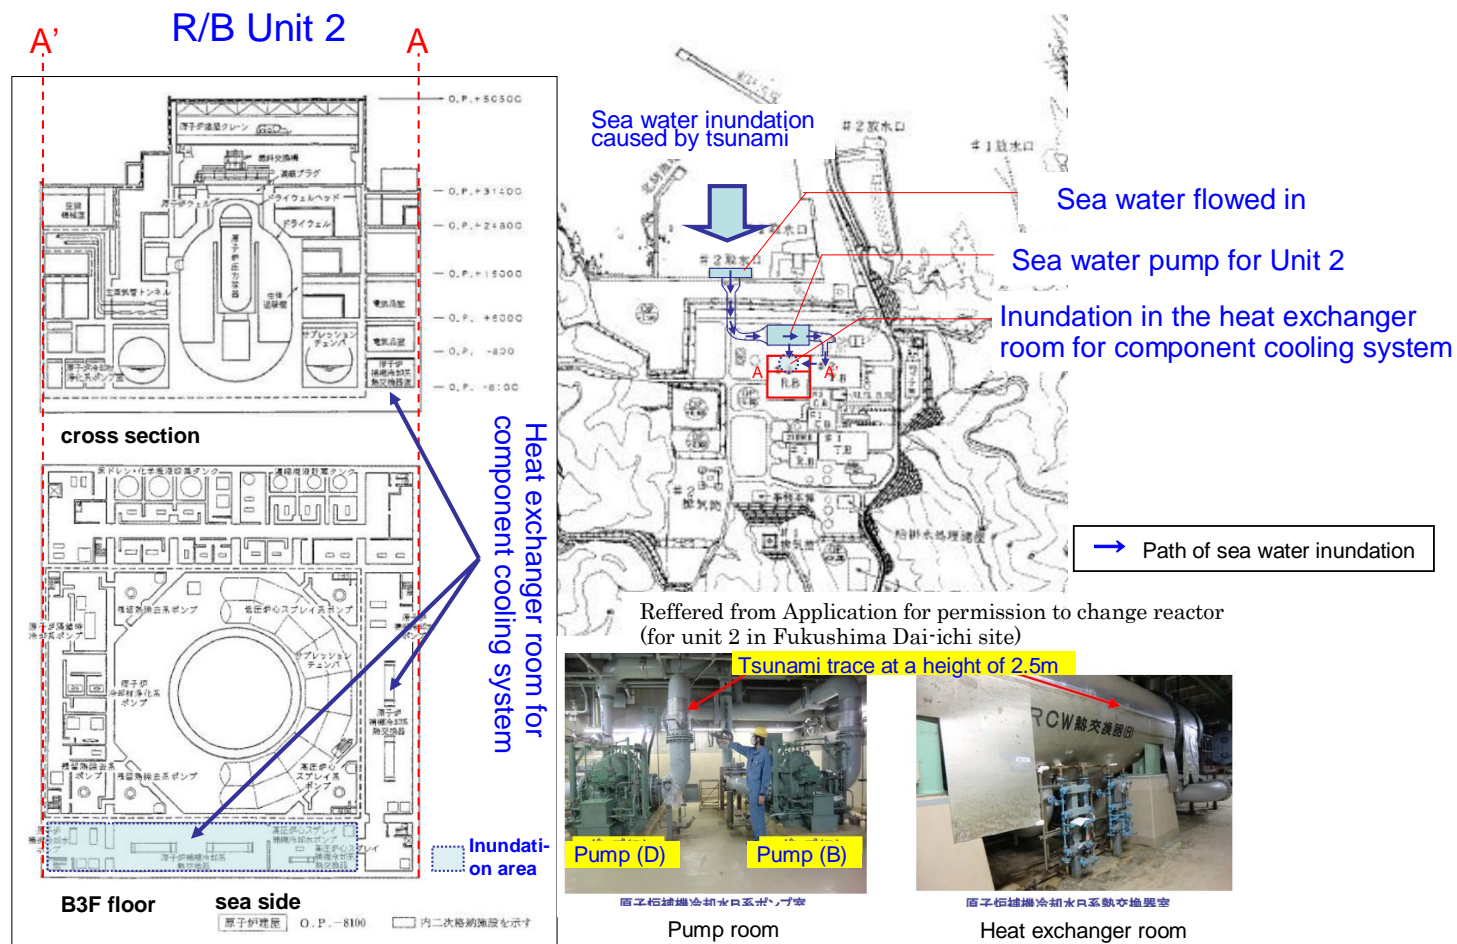
Fig. III-3-5(a) Inundation in the heat exchanger room for a component cooling system (1) at Onagawa NPS.

Figure III-3-5(a) and Figure III-3-5(b) show the layout of intake channel, seawater pump, seawater pump room, and heat exchanger room of the component cooling system. As shown in the figure, the seawater pump room is located on the higher site, which is 14.8 m high, about 100 m away from the coast, and is structurally designed to prevent being submerged by a run-up tsunami. Inside the room, the tide gauge is installed with an opening. This tide gauge is designed to allow the automatic stop of the seawater pump in short of seawater due to the backrush of a tsunami.

The observed tsunami height was 13 m, and despite the land sinking, the tsunami did not cause the seawater pump room (on the site as high as 13.8 m, adjusted to sinking by about 1 m) to be directly submerged. However, as the water level rose due to the tsunami, the water level in the underground intake pit also rose as shown in Figure III-3-5, caused by the siphon phenomenon. This resulted in seawater overflowing through the opening of the tide gauge into the seawater pump room. Then the seawater flowed from the pump room, via the trench, into the basement floors of the reactor buildings, causing the heat exchanger room of the component cooling water system in the second basement to be submerged. In addition, the component cooling water pump of Unit 2 was also submerged, which thereby caused the cooling function of emergency diesel generators to be lost, with two units stopped out of those three generators.

Tohoku Electric Power Company Inc. took measures to prevent the piping penetrations and the cable tray penetrations from the seawater pump room to the trench. They stated that the company would remove the water gauge in the seawater pump room and relocate it to an improved area to prevent exposure to water, and they would also set up a flood barrier around the seawater pump room.

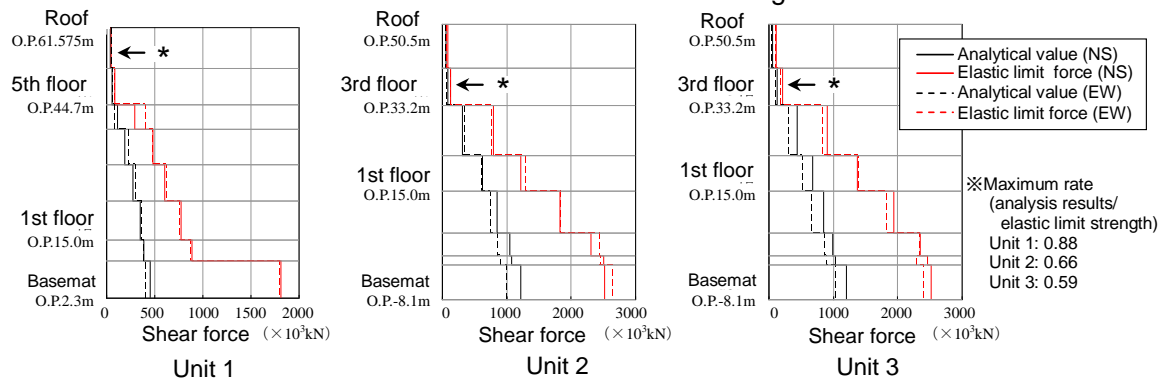
Fig. III-3-6 Verification of shear strain and shear force acted on seismic walls at each floor in R/Bs of Onagawa NPS.

Tohoku Electric Power Company conducted an integrity assessment of the reactor buildings, based on the same procedures as the integrity assessment for the building structure of the Kashiwazaki-Kariwa Nuclear Power Station after the Chuetsu-oki Earthquake in July 2007. The response analyses on the reactor buildings of Units 1 to 3 were made with the observed acceleration records as the input of seismic ground motion. Figure III-3-6 shows the shear strain and shear force at the building by floor for each

Unit. It can be seen that shear strain at each floor was below the JEAG4681-2008 evaluation criteria ( $2.0 \times 10^{-3}$ ), and shear force was also below the elasticity limit. The ratio between the evaluation criteria and shear strain results at each floor was around 2.5 to 5.6.

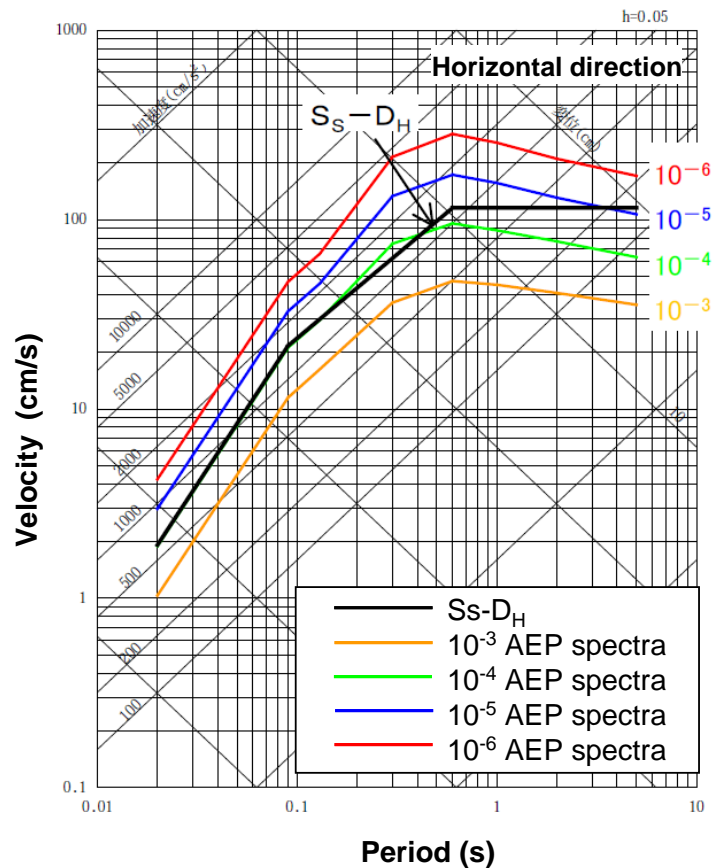
Fig. III-3-7 DBGM Ss and Uniform Hazard Spectra (UHS) for Tokai Dai-ni NPS.

Figure III-3-7 shows the evaluation of the uniform hazard spectrum of DBGm Ss for Tokai Dai-ni NPS. Response spectra for Ss-D<sub>H</sub> are also shown here. It can be seen that the exceedance probability for standard seismic ground motion Ss is approximately between  $10^{-4}$  and  $10^{-5}$  per year.

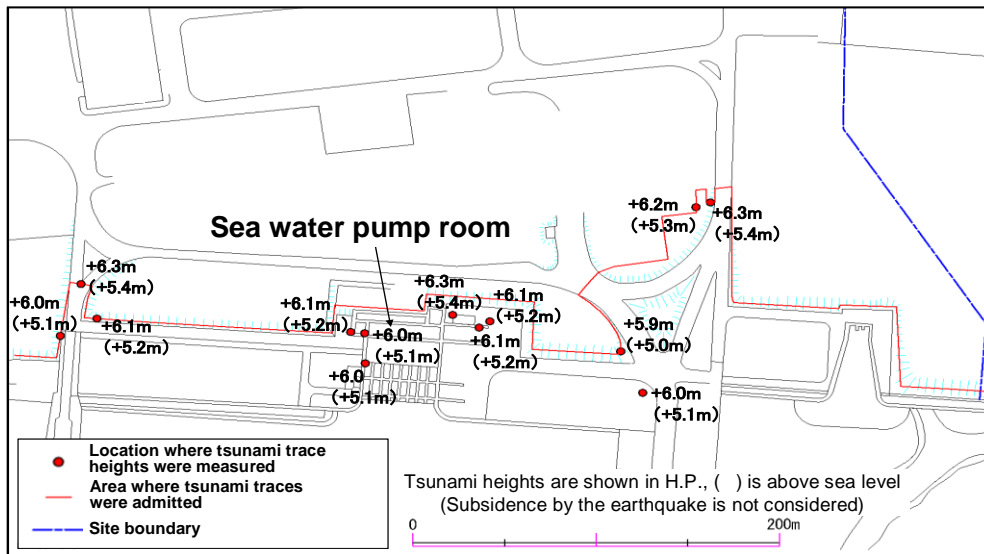
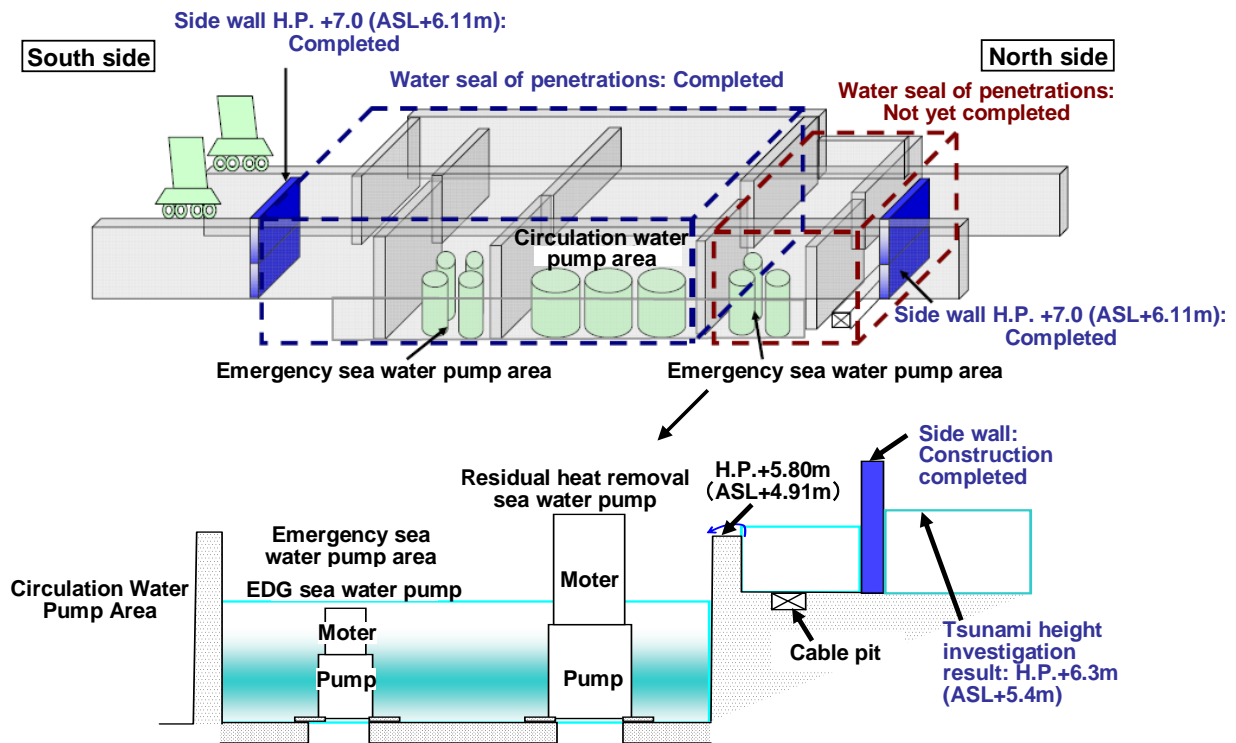
Fig. III-3-8 Map of the areas with tsunami traces identified at Tokai Dai-ni NPS.

Japan Atomic Power Co. has been surveying traces of how high the tsunami ran up on the NPS site. The results are shown in Figure III-3-8. The tsunami marked traces as high as H.P. + 5.9 m (5.0 m above sea level, H.P.: the reference surface for construction of Hitachi Port) to H.P. +6.3 m (5.4 m above sea level, provisional). Based on these findings, the height of the run-up tsunami was estimated to be approximately H.P. +6.3 m (5.4 m above sea level, provisional). The tsunami did not reach H.P. +8.9 m (8 m above sea level), on which the major buildings are located.

The tsunami flooded the north emergency seawater pump area in the seawater pump room, as shown in Figure III-3-8. Consequently one of three seawater pumps for emergency diesel generators was submerged, and one of three emergency diesel generators stopped. Meanwhile, the other two emergency diesel generators were able to operate, successfully ensuring emergency power supply.

When the earthquake hit the site, the north emergency seawater pump room was under leveling construction of its sidewall as protection against tsunami (H.P. +5.8 m, 4.9 m above sea level). This construction work put in place a new sidewall up to H.P. +7.0 m (6.1 m above sea level) outside the existing sidewall, but the waterproof sealing of the penetration (small holes for electric cables, etc.) of the wall had not been completed, and as a result the seawater came through the small holes into the pump room.

The height of the run-up tsunami was approximately H.P. +6.3 m (5.4 m above sea level), not going beyond the new sidewall, which was as high as H.P. +7.0 m (6.1 m above sea level).
