2. Damage caused by the earthquake and tsunami hitting Fukushima NPSs

(1) Seismic ground motion and tsunami height observed at Fukushima Dai-ichi NPS

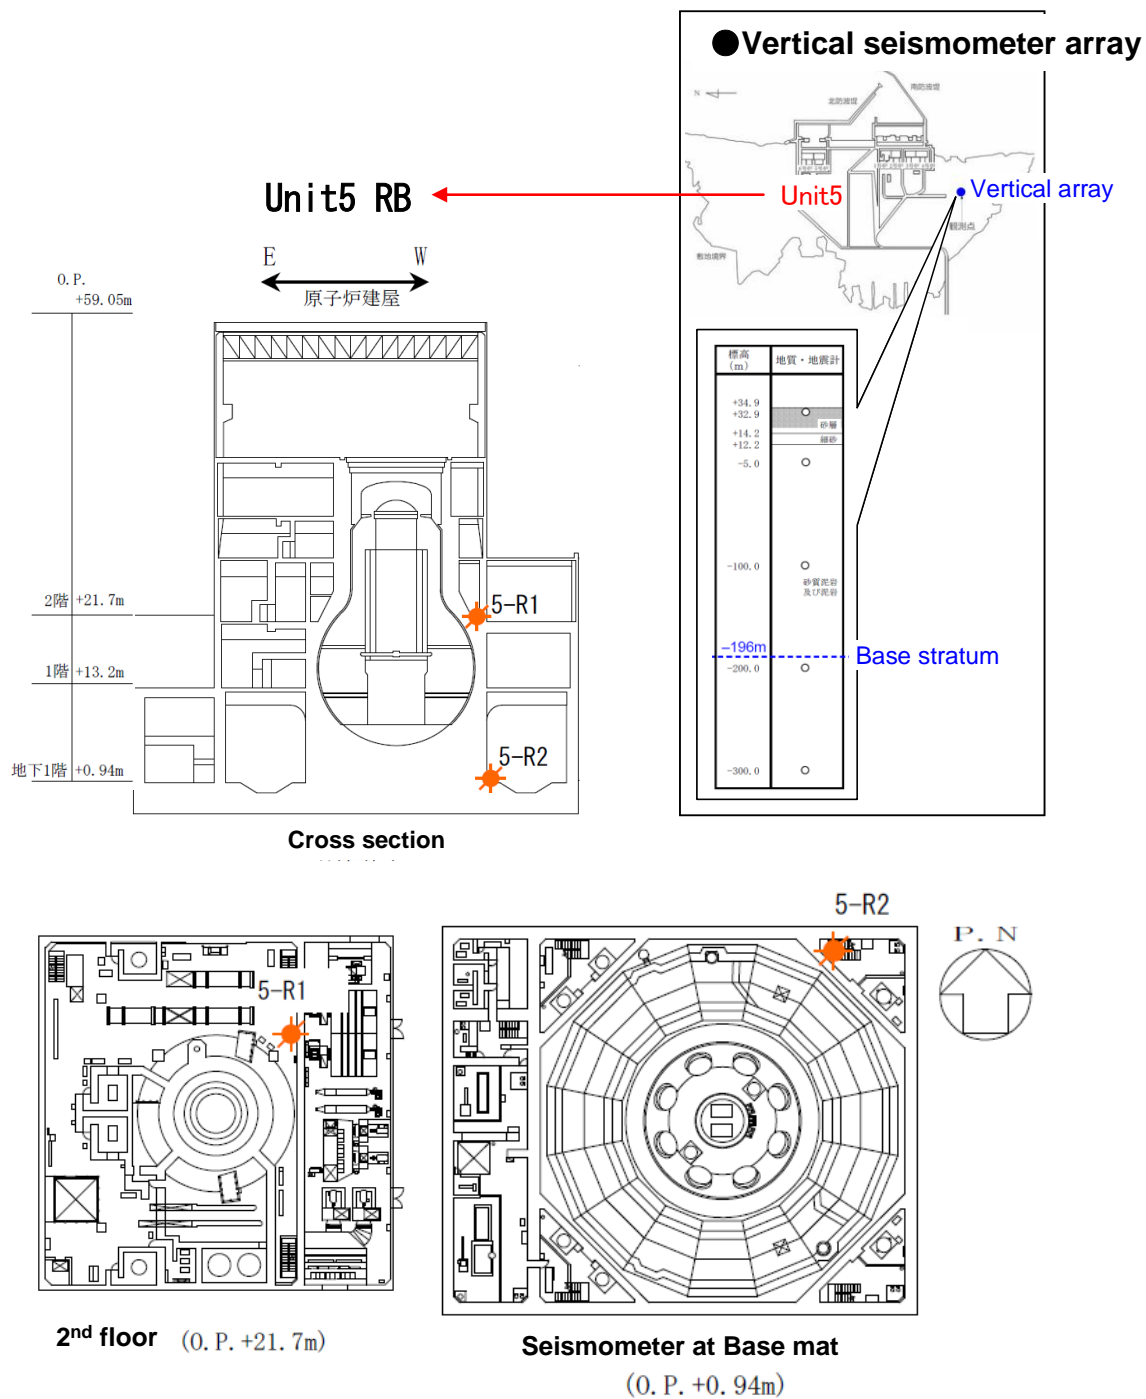
Fig. III-2-1 Deployment of seismometers at Fukushima Dai-ichi NPS and R/B in unit 5.

The seismic ground motion observation system of Fukushima Dai-ichi NPS, as shown in Figure III-2-1, consists of seismometers installed on the first basement and the second floor of the reactor buildings, seismometers in underground down-hole array (five seismometers in each part hole) at two parts in the south and north of the site and observation record device. Seismometers observe acceleration time history of two horizontal and vertical components.

Seismometers are installed at 53 points in Fukushima Dai-ichi NPS. Seismic ground motion was recorded at 29 points out of them. However, according to TEPCO's investigation, records of acceleration time history were interrupted at around 130 to 150 seconds at seven points. TEPCO's investigation revealed that the cause was failure of recoding device software.
